Article

Assessment of the Structural Integrity of the Roman Bridge of Alcántara (Spain) Using TLS and GPR

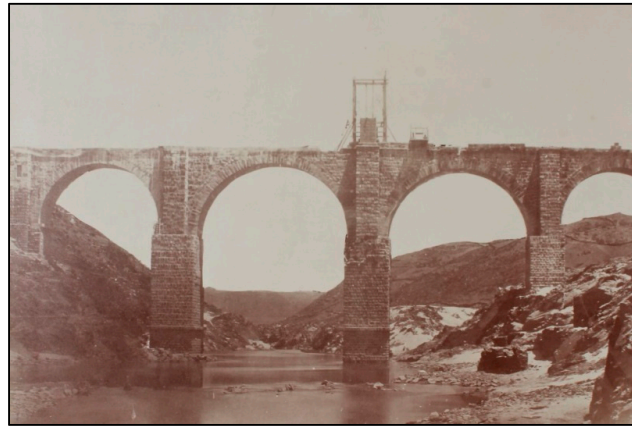
Figure 3. Photograph from downstream during the reconstruction work of the triumphal arch in 1857 after having reconstructed the fifth arch, which had been destroyed [16].

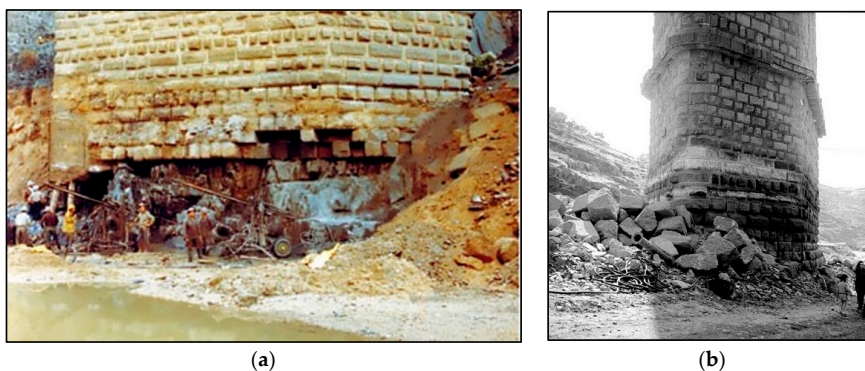
The other element that has done great damage is water flow, which has undermined the left part of pillar number 4 (Figure 4a), which had led to considerable cracking in its upper part, documented by the architect Diego de Ocha in 1804 [17], probably resulting from the river Tajo swelling up prior to 1763, this being the oldest date of the sheets recording water levels [18,19]. Attention was paid to the undermining of the pillar during the repair work of 1857, and was treated with rockfill at the base of the pillar to protect it [10]. However, the problem appeared once again in 1969 when the river ran dry during the construction work of a reservoir upstream. The pillar had lost the rockfill protection and a considerable number of stones, leaving a hollow 4 m high and 2 m deep along the 17 m of the side of the pillar [20] (Figure 4).

Figure 4. (a) Repair work on the undermined pillar number 4 left side [20]. (b) Condition of pillar number 3 at the same time [21].

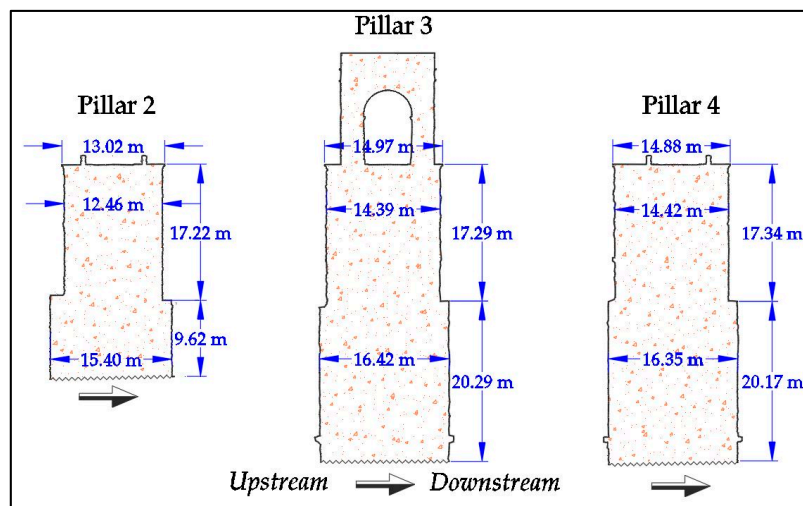
Figure 9. Transversal sections of pillars 2, 3 and 4.

In the latest measurements taken in 2017, no collapse was detected in the bridge's pillars. The only variations observed on the vertical plane were those corresponding to recesses and protrusions of the

blocks as a result of drawing the characteristic dressed stone blocks of the bridge in representation of the standard sections (Figure 9).

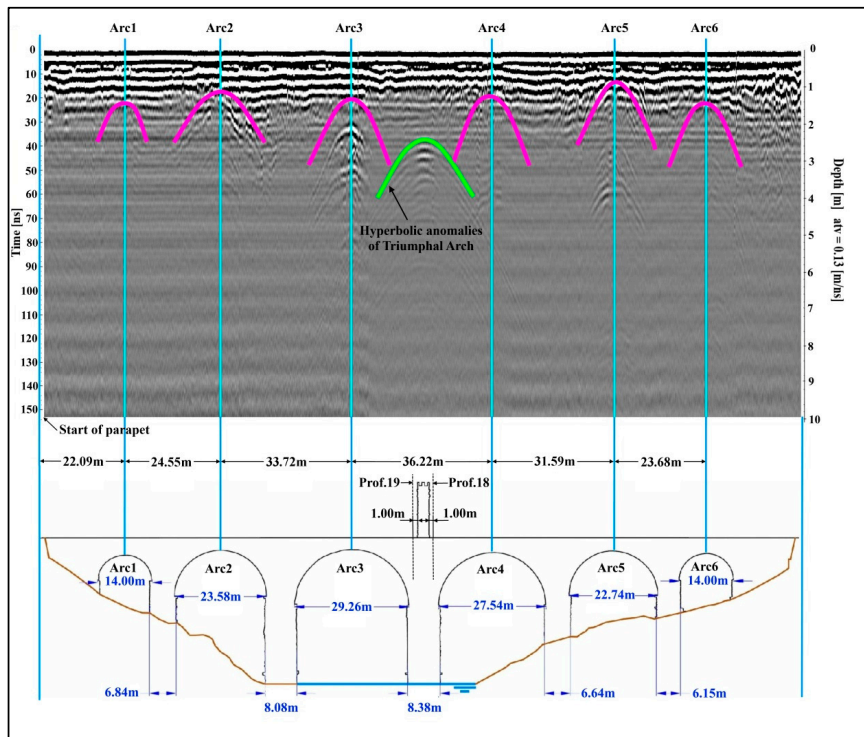
Longitudinally, Figure 10 shows the composition of the elevation of the bridge and the composed radargram (Prof 8–Prof 12) of transect L1 with the 200 MHz antenna, which covers practically the entire length of the bridge in the W–E direction (≈ 190 m). Hyperbolic reflections are quite clearly observed, corresponding longitudinally with the location of the arches of the bridge. In depth, different layers more or less horizontal can be appreciated up to 20 ns (1 m, with $v = 0.13$ m/ns) approximately. Over these layers, the beginning of the different hyperbolic anomalies can be seen, which may correspond to the presence of granite stone making up the filler, as the arches of the bridge are at depths of over 3.5 m.

The hyperbolic anomaly detected in the central part at 40 ns is quite interesting because it does not correspond to any of the arches of the bridge. The anomaly is produced by the Triumphal Arch that is on the bridge. The radiograms Prof 8 to 12 were collected with a 200 MHz not shielded antenna. In some specific structures, these reflections can be seen with this antenna, as shown in Figure 10.

Figure 10. Radargrams Prof 8 to Prof 12 superimposed on the longitudinal elevation of the bridge from the TLS survey.

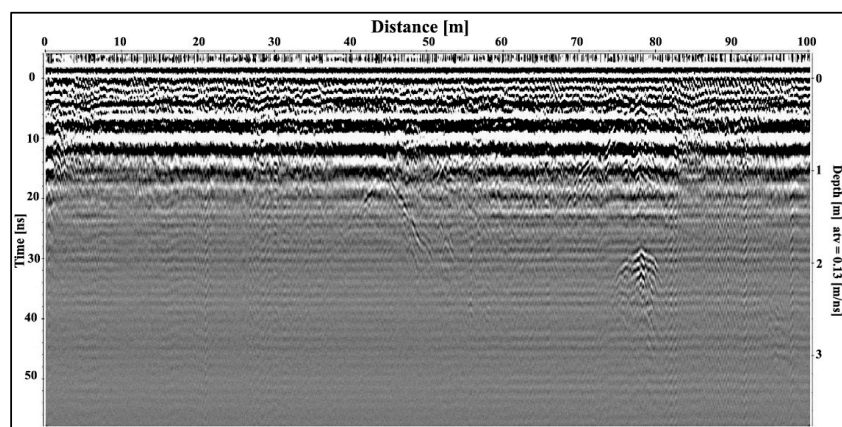
This is seen in more detail in radargrams Prof 16 and Prof 17 collected in the first 100 m with the 500 MHz antenna (Figures 11 and 12) and the equipment configured for maximum depths of 3.5 and 1.5 m respectively. In Prof 16, we can confirm the hypothesis of the anomaly produced by the Triumphal Arch, because when collecting the radargram with a shielded antenna, the anomaly does not appear after 90 m.

Figure 11. Radargram Prof 16 on transect L1, length 100.3 m and maximum depth 3.5 m, obtained by the 500 MHz antenna.

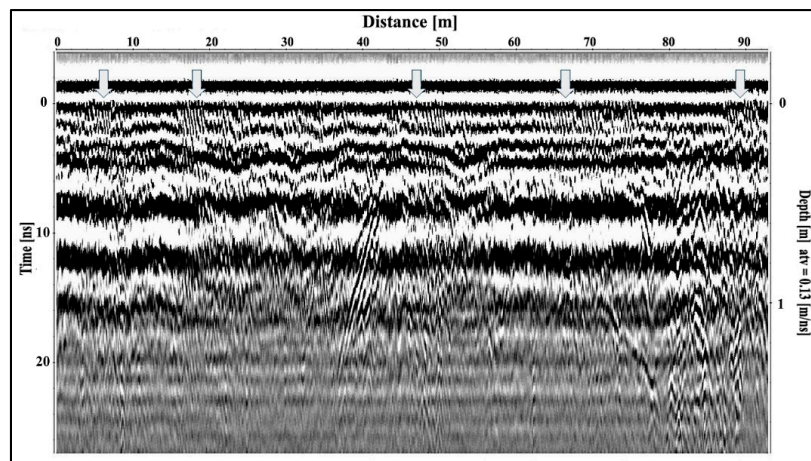
Figure 12 shows in greater detail the different strata of the bridge's filler. The first 20–25 cm would correspond to granite paving blocks, each of which is between approximately 5 and 10 cm thick. At greater depth, horizontal reflections are seen that configure an area up to a depth of 1 m made up of strata of greater thickness (around 20 cm) which may correspond to the different layers of the compacted ground filler.

Figure 12. Radargram Prof 17 on the transect L1, length 92.9 m and maximum depth 1.5 m, obtained by the 500 MHz antenna.

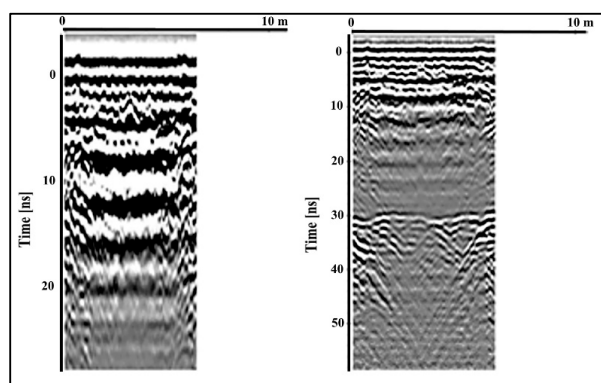
Regarding the transversal plane, Figure 13 shows the radargrams Prof 18 and Prof 19 (500 MHz antenna). In both, the reflections can be clearly appreciated on the lateral walls of the bridge, as well as the different layers of paving and compacted ground. Radargram Prof 19 also reveals a clear horizontal reflection at around 30 ns of depth (≈ 2 m), which would correspond to the stonework. Nevertheless, in Figure 12, longitudinal, the hyperbolic anomalies appeared higher up in the keystones of arches 2, 3, 4 and 5.

One hypothesis to explain the reduction of the height of the anomaly between the longitudinal and the transversal data is that the filler is horizontal up to a depth of approximately 2 m. This strengthens the area of the kidneys of the arches, which is weaker in the arches. If the thickness of the arch is deducted in the middle of those arches, the resulting thicknesses are less than 2 m (Figure 8).

Figure 13. Radargrams Prof 18—left—and Prof 19—right—collected by the 500 MHz antenna on transect T1.

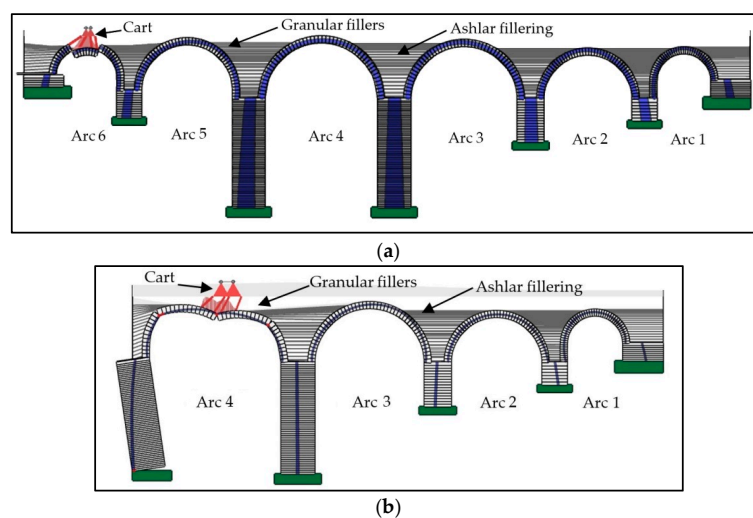
Figure 15. (a) Failure by slipping at position S0.1. (b) Failure by mechanism.

Of the conditions the bridge has been in, the one that led to the lowest safety levels was the demolition of arch number 5, which lasted from 1809 until 1857. Moreover, in the event of the exhaustion mechanism (Figure 15b) on the left side of the base of pillar number 4 in that condition, the stonework would open up. Taking into account that it is in this area that the loss of stonework took place before being repaired in 1857 and 1969 (Figure 4a), it can be confirmed that the origin of this loss was the opening of the joints in the stonework due to the imbalance of the thrust of arch number 4 following the demolition of arch number 5. This fissuring facilitated the entrance of water and the loss of the stones. Figure 4b shows the lower stones of pillar number 3 subjected to the same repairs. They only show signs of wear, since in that case the loads descend the pillar through the centre without causing tractions in its face (blue line in Figure 15b).
