**EVALUACIÓN DE TÉCNICAS DE  
RECUPERACIÓN DE ZONAS ACARCAVADAS  
MEDIANTE MODELOS 3D DE ALTA  
RESOLUCIÓN**

Programa de Doctorado en  
Desarrollo Territorial Sostenible

**2021**

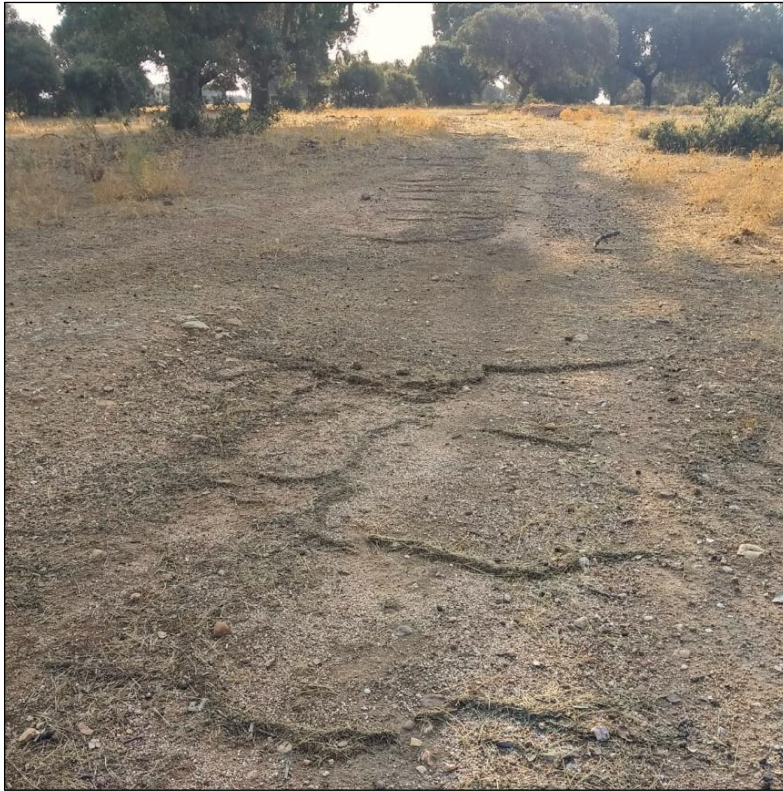
**Figura 1.** Evidencias de erosión laminar sobre una vertiente en una finca de Extremadura.

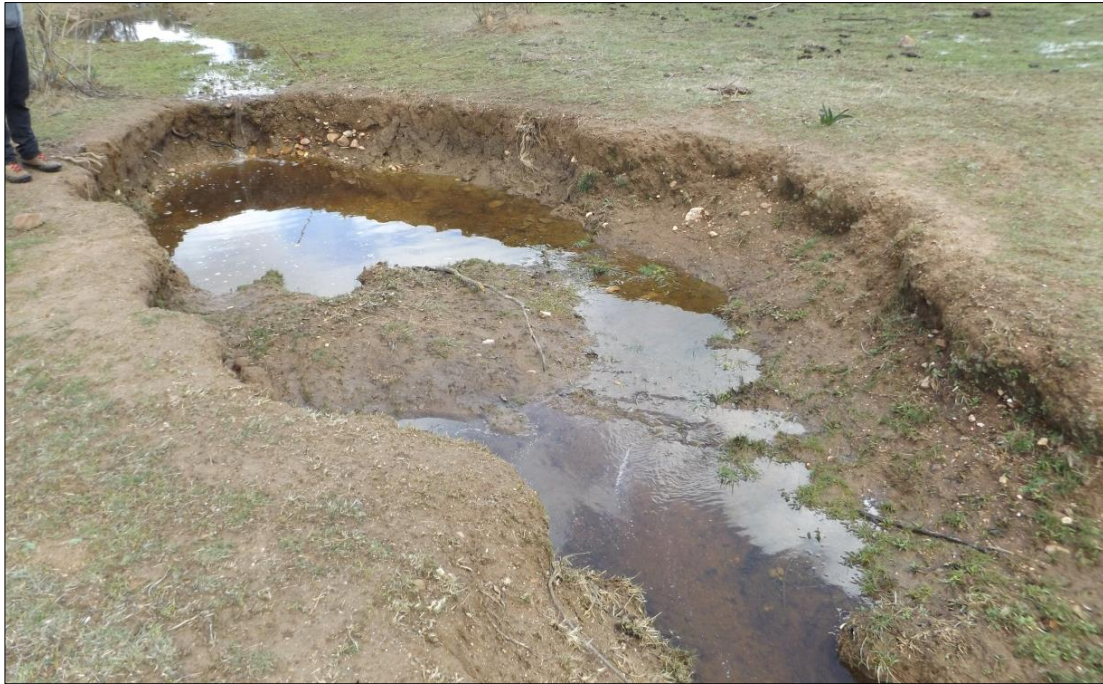
**Figura 3.** Cabecera de una cárcava de fondo de valle localizada en una finca de Extremadura.

forman parte de la propia red de drenaje (Gómez-Gutiérrez et al., 2009a; Thomas et al., 2004). Morgan (1997) utilizó la posición topográfica para diferenciar dos tipologías: cárcavas de vaguada o fondo de valle y de ladera. También habría que indicar las cárcavas desarrolladas por estructuras construidas o modificadas por el hombre (carreteras, caminos, canalizaciones, etc.) (Imwangana et al., 2015; Poesen, 2018). Las cárcavas presentan unos elementos característicos comunes como son una o varias cabeceras (Figura 3), un canal de desarrollo y una desembocadura.

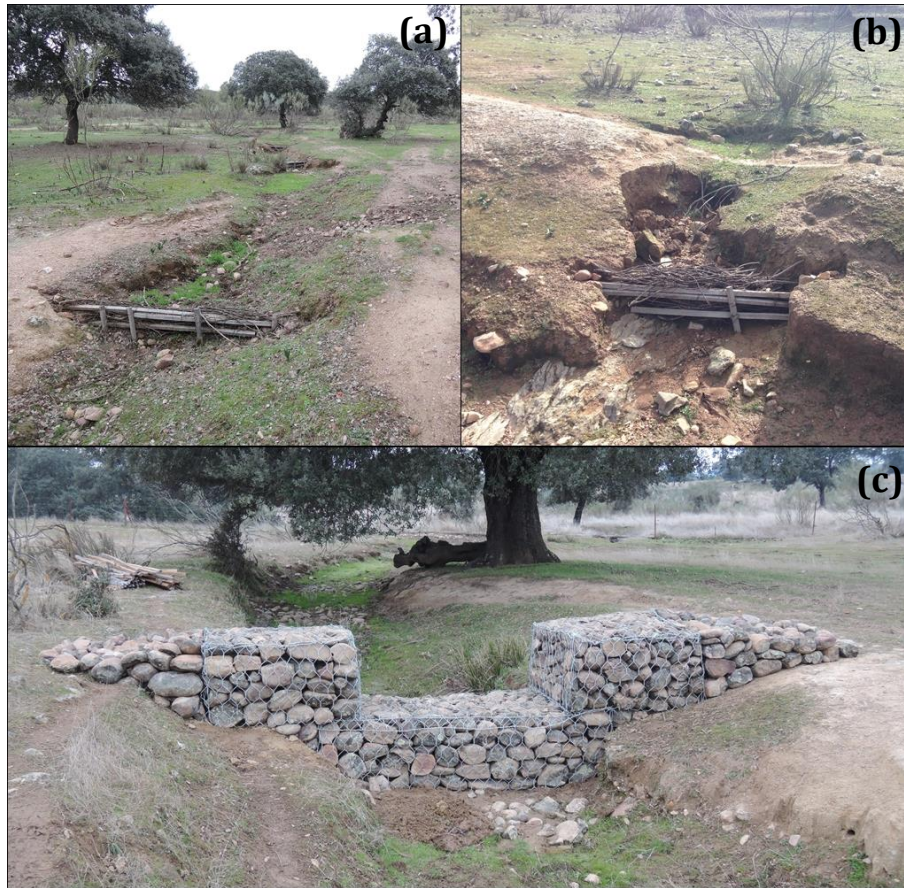
**Figura 6.** Ejemplos de medidas de corrección y control de cárcavas implementadas en una cuenca de dehesa en Extremadura: (a) una fajina hecha con escobas e implementada perpendicular a la cárcava, (b) una fajina instalada en una cabecera lateral y (c) un gabi6n formado por cantos y bloques de cuarcita y construido perpendicular a la cárcava.

Las estructuras temporales sirven para facilitar el crecimiento de la vegetación. Retienen los sedimentos y la humedad (Sharma et al., 1994), y pueden ser: fajinas compuestas de ramas secas, apiladas entre estacas verticales (Figura 5 y 6a-b) o barreras de adobe.

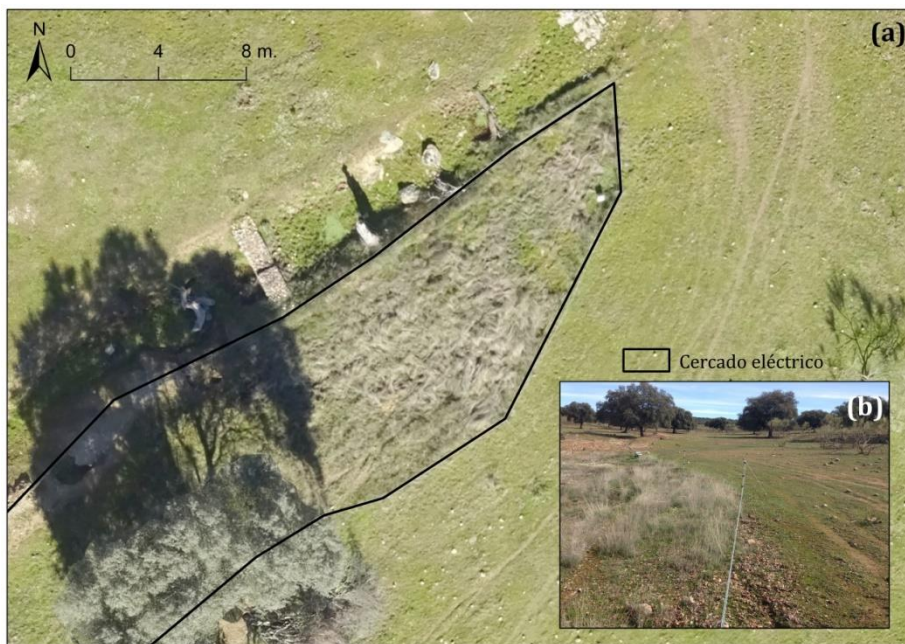
**Figura 7.** (a) Vista a6rea de la superficie cercada en la que se aprecia las diferencias en la cobertura de plantas herb6ceas y (b) fotograf1a del cercado el6ctrico.

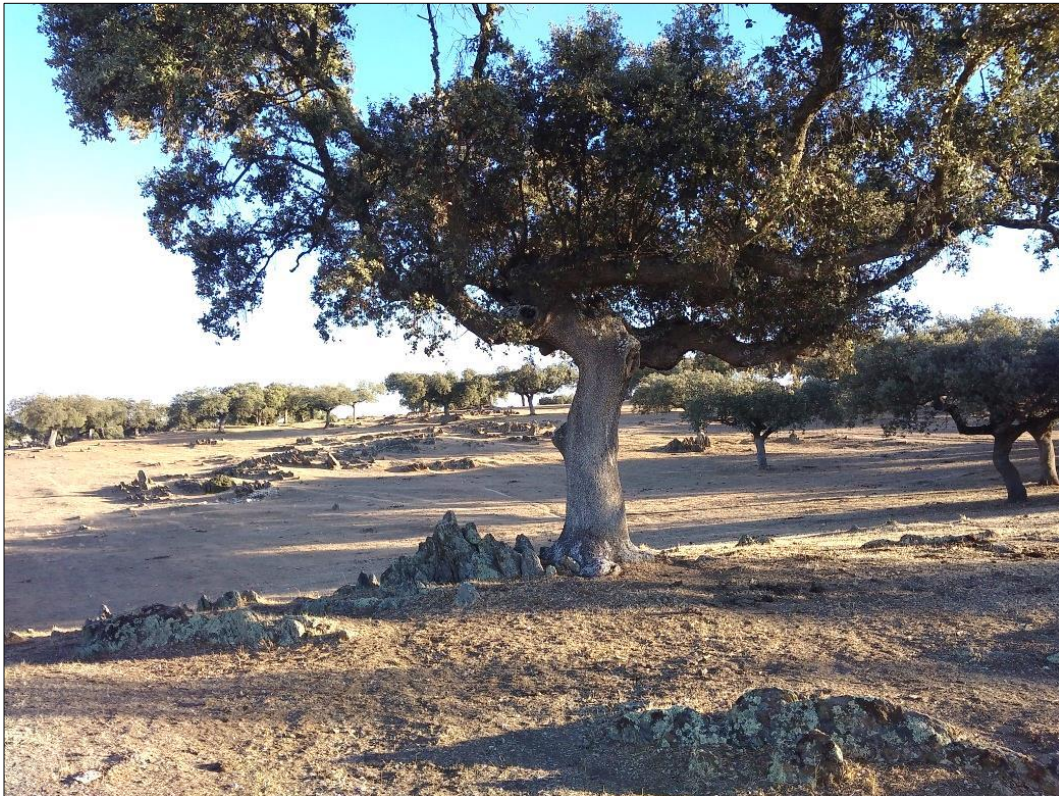
**Figura 8.** Vertiente con suelo desnudo en la Dehesa Boyal de Monroy como consecuencia de la ausencia de lluvias y del pastoreo, y los efectos de la erosión hídrica con los afloramientos verticales de pizarra, conocidos como *dientes de perro*.

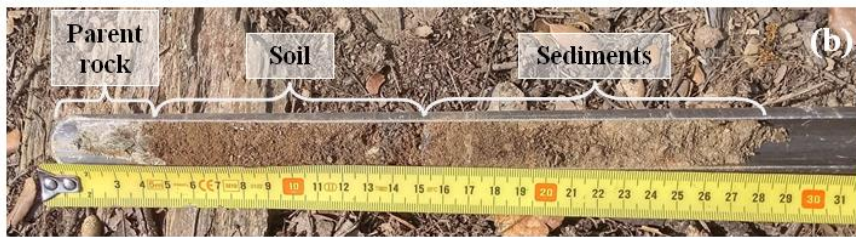
**Figure 15.** (a) Relationship between the estimated sediment depth and the sediment depth measured in the field and (b) example of a sediment core illustrating the original soil and the sediment deposited.

Additionally, the depth of the sediment deposit estimated by this method (sUAS+SfM+ANUDEM+DoD) was validated using field data. An auger was used to sample the depth of the deposit at 28 different locations within 27 check dams and observed values were tested against the estimated depths (by the DoD approach).

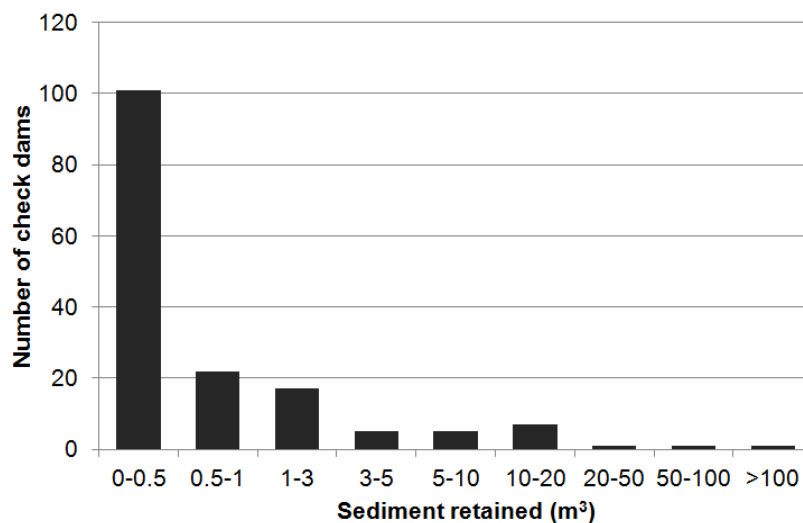
**Figure 16.** Frequency distribution of sediment volume in check dams.

Table 2 presents descriptive statistics of the sediment volumes retained in check dams located in different catchments. Catchment A presented a higher volume of sediments deposited in the check dams. Check dams in catchment A were the first established (in 1994), however no statistical relationship was observed between the amounts of sediment trapped and the age of the check dams. The three check dams with the largest amount of retained sediments were located in catchment A ( $\geq 38.43 \text{ m}^3$ ). On the contrary, catchments B and D presented fewer check dams with larger volumes than catchments A, C, E and F. The average rate of deposition at each dam site was  $0.133 \text{ m}^3 \text{ y}^{-1}$ , resulting in a deposition rate of  $0.141 \text{ m}^3 \text{ ha}^{-1} \text{ y}^{-1}$ . In accordance with the information provided by the local government and managers, the check dams have never been emptied.

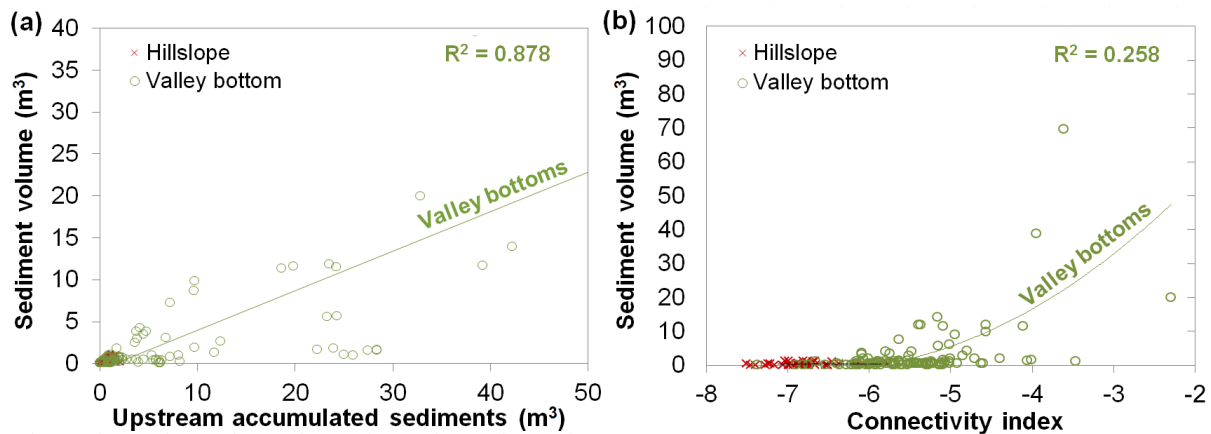
**Figure 18.** Relationship between the sediment volume in the check dams and a) upstream accumulated sediments and b) CI (at check dam). Equations and regression lines showed in both plots refer exclusively to valley bottom check dams.

walls (for both topographic positions: valley bottoms and hillslopes). Check dams located in hillslopes with large amounts of sediments were observed in catchments with low slope gradient, while check dams with small amounts of sediments were located in catchments with high slope gradient. A positive correlation between the sediment volume and the upstream accumulated sediments was observed, being higher in valley bottoms than in hillslopes ( $R^2 = 0.878$ ; Figure 18a).

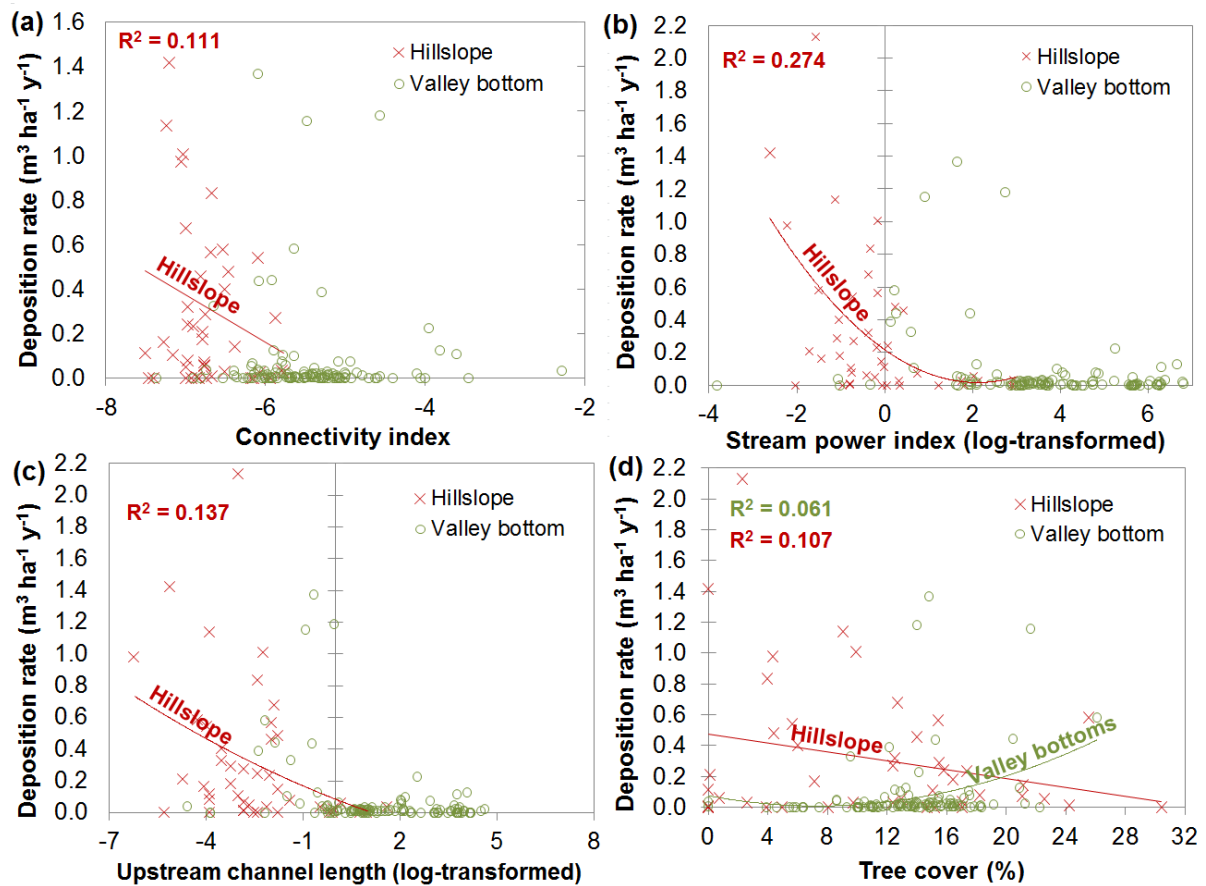
**Figure 19.** Relationship between the deposition rate in check dams and (a) CI (at check dam), b) stream power index (log transformed), (c) upstream channel length (log transformed) and (d) tree cover (for the catchment of every individual check dam).

Figure 19 presents the relationship between the deposition rate and the physical-environmental variables which are significantly correlated. Low deposition rates were observed equally in check dams with very different values of connectivity and channel slope, while high deposition rates were registered only in check dams with low CI ( $R^2 = 0.111$ ; Figure 19a) and high channel slopes. Furthermore, check dams with low deposition rates were found in catchments with high SPI ( $R^2 = 0.274$ ; Figure 19b) and with long upstream channels ( $R^2 = 0.137$ ; Figure 19c), while check dams with high deposition rates were identified in catchments with low SPI values and short upstream channels.

According to the topographic position, low deposition rates for valley bottom check dams can be found in catchments varying with respect to size of check dam walls, channel slopes, tree cover and animal path density, while high deposition rates only found in long check dam walls, with high channel slopes and in catchments with high tree cover ( $R^2 = 0.061$ ; Figure 19d) and with high path density. Check dams located in hillslopes with low deposition rates were observed in catchments with different CI and

different tree cover. However, high deposition rates can be found in catchments with low CI ( $R^2 = 0.111$ ; Figure 19a) and low tree cover ( $R^2 = 0.107$ ; Figure 19d).

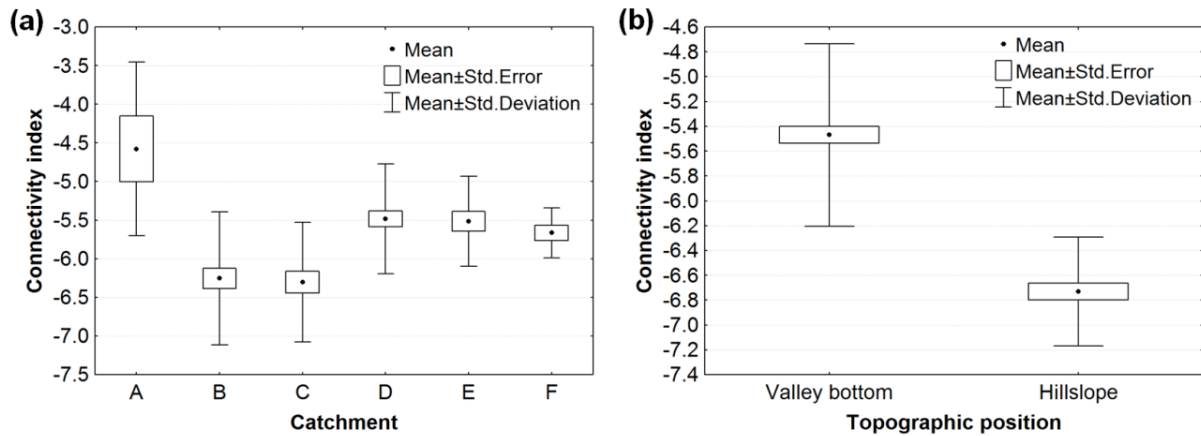
**Figure 21.** (a) CI values for check dams grouped by catchment and (b) CI values according to the topographic position of the check dams ( $p < 0.05$ ).

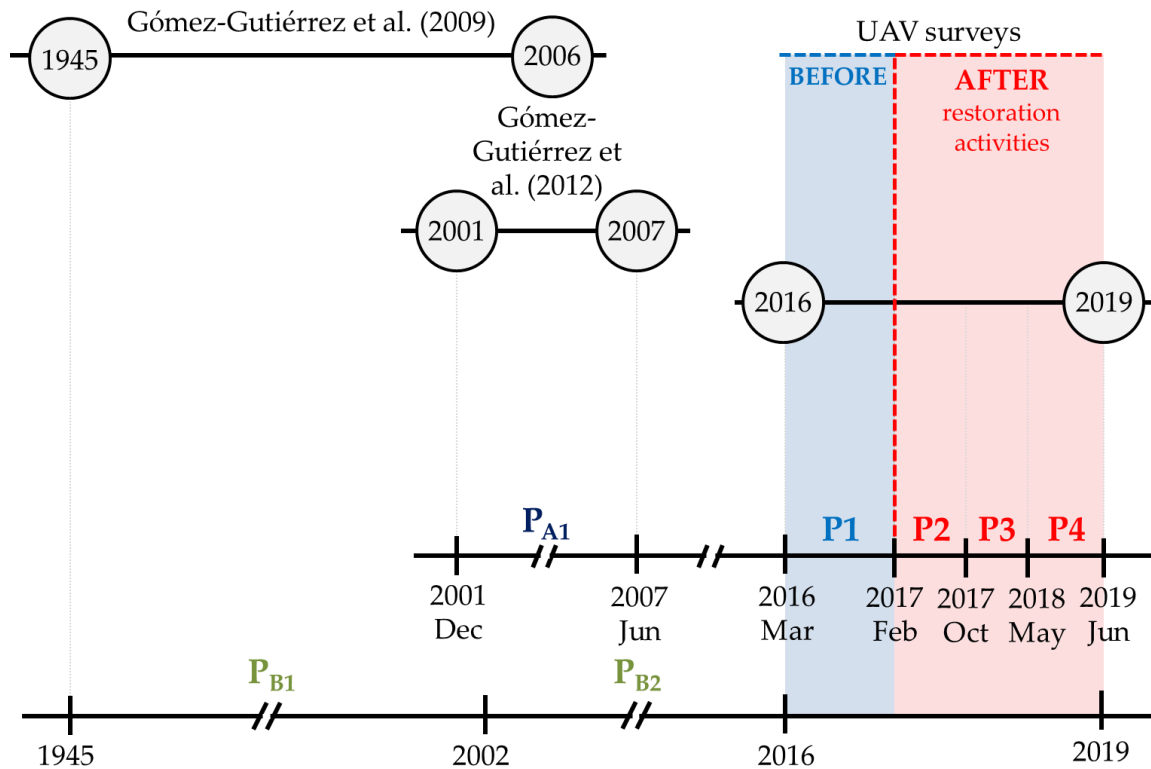
**Figure 23.** Time periods considered in the study as a result of the availability of topographic data. The vertical red line displays the date of the restoration measure implementation.

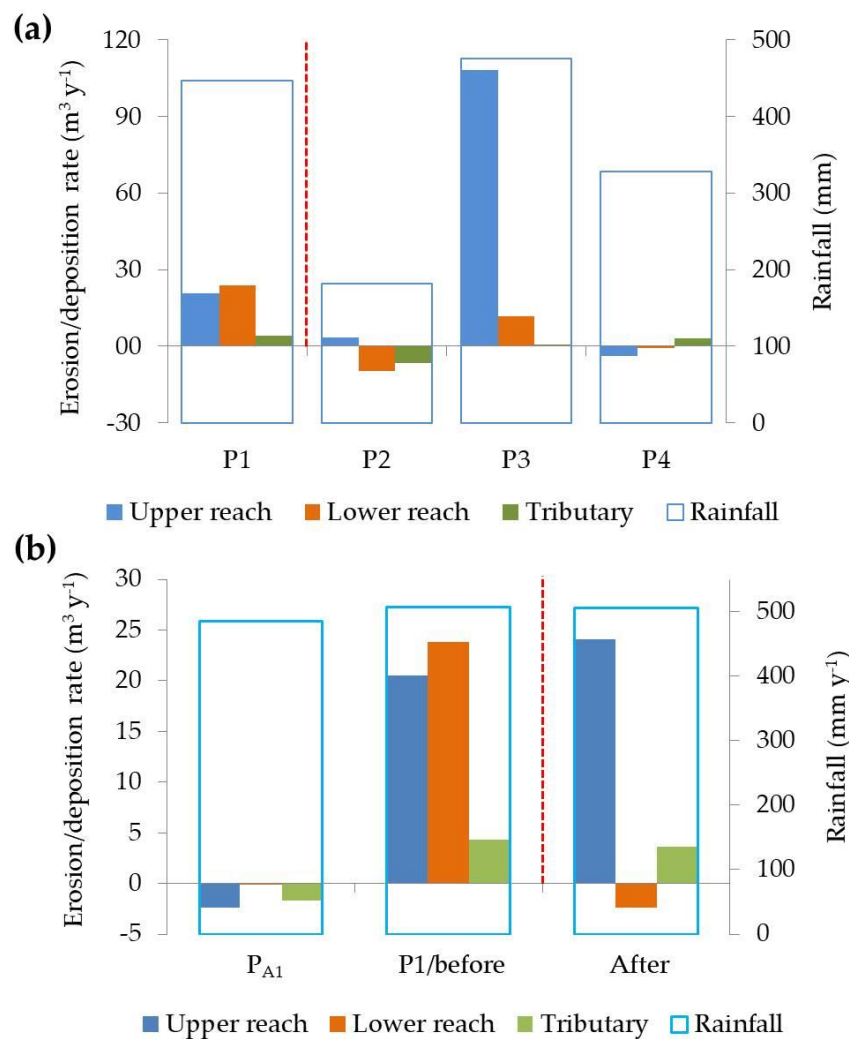
**Figure 24.** (a) Net erosion/deposition rate registered at the different reaches by period and (b) net erosion/deposition rate recorded before and after the establishment of the restoration measures. Period PA1 (from December 2001 to June 2007) refers to the data obtained by Gómez-Gutiérrez et al. (2012), who surveyed 28 fixed topographic cross sections. The vertical red line indicates the establishment of the restoration measures.

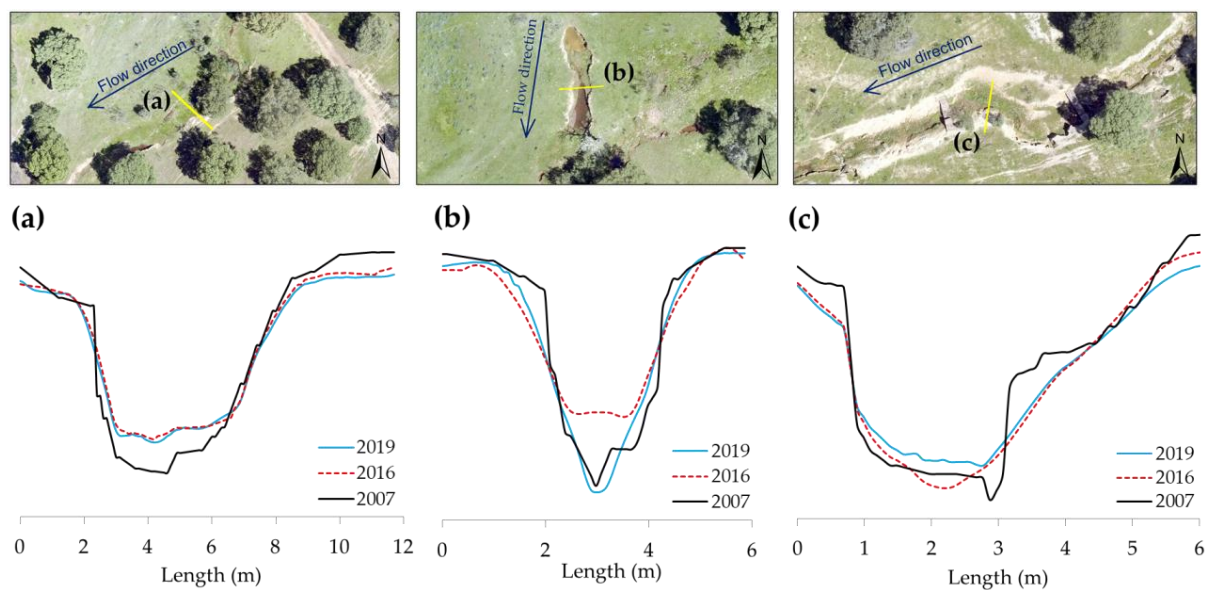
**Figure 27.** Evolution of three topographic cross sections located at (a) the lower reach, (b) the tributary, and (c) the upper reach from a downstream view, with a spatial resolution of 0.02 m.

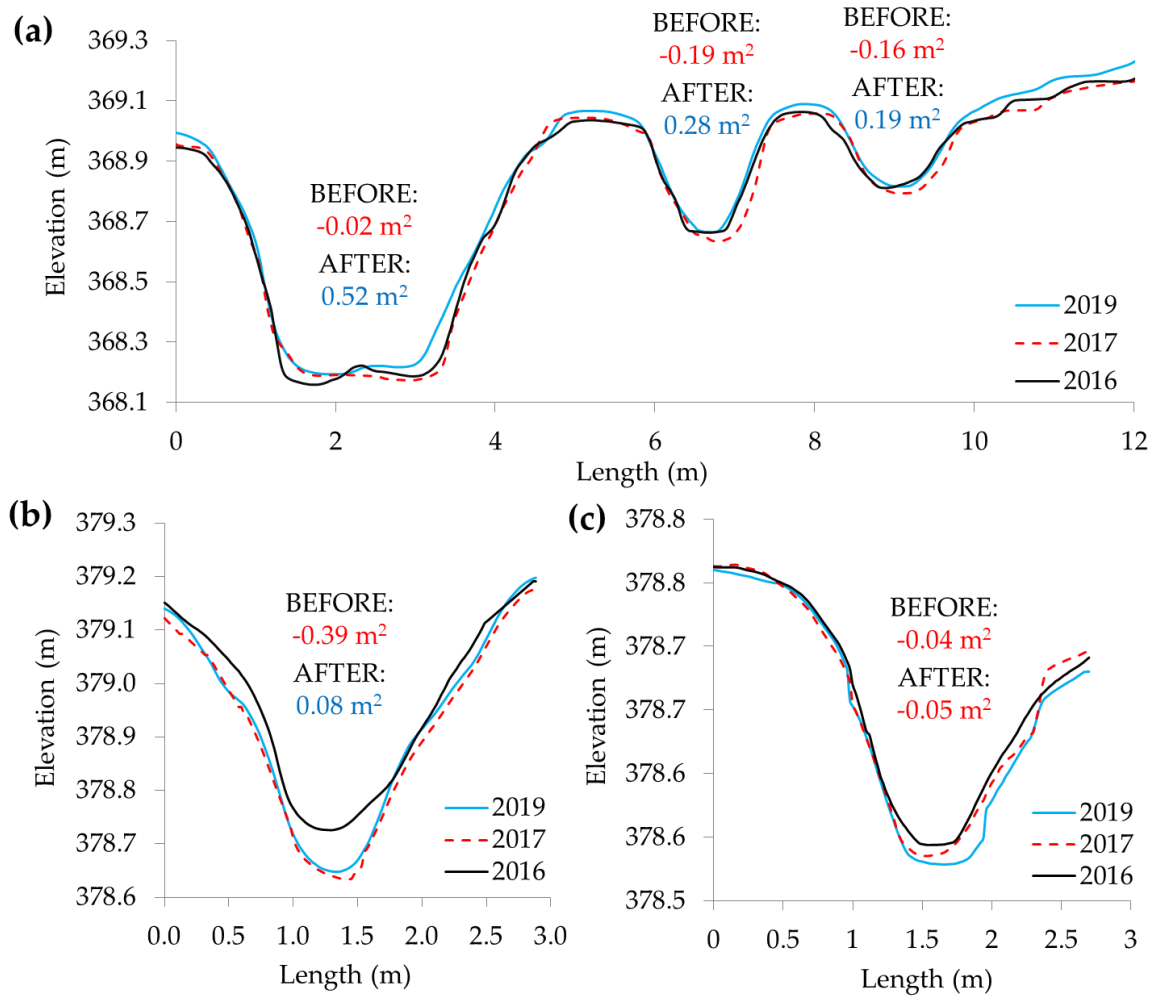
**Figure 33.** Cross sections (CSs) indicated in Figure 32: (a) CS-1, (b) CS-2, and (c) CS-3, before the installation of the restoration measures (2016) and afterwards (2017–2019).

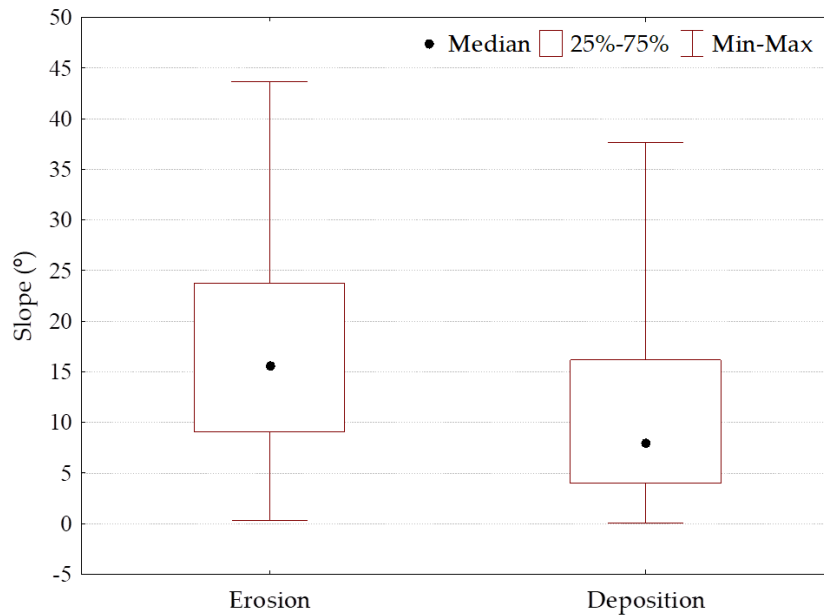
**Figure 36.** Initial slope gradient (calculated using the DEM from 2016) for pixel that experienced erosion or deposition from 2016 to 2019 ( $p < 0.05$ ).
