Article

Assessment of the Structural Integrity of the Roman Bridge of Alcántara (Spain) Using TLS and GPR

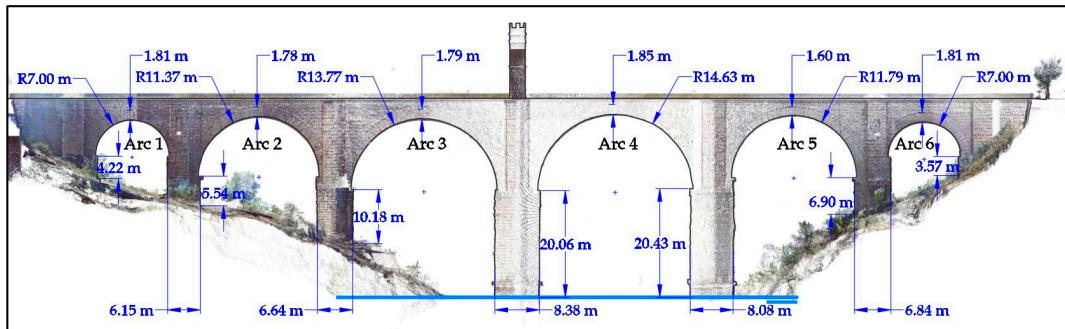
Figure 8. Longitudinal section downstream from the Roman bridge of Alcántara.

One hypothesis to explain the reduction of the height of the anomaly between the longitudinal and the transversal data is that the filler is horizontal up to a depth of approximately 2 m. This strengthens the area of the kidneys of the arches, which is weaker in the arches. If the thickness of the arch is deducted in the middle of those arches, the resulting thicknesses are less than 2 m (Figure 8).

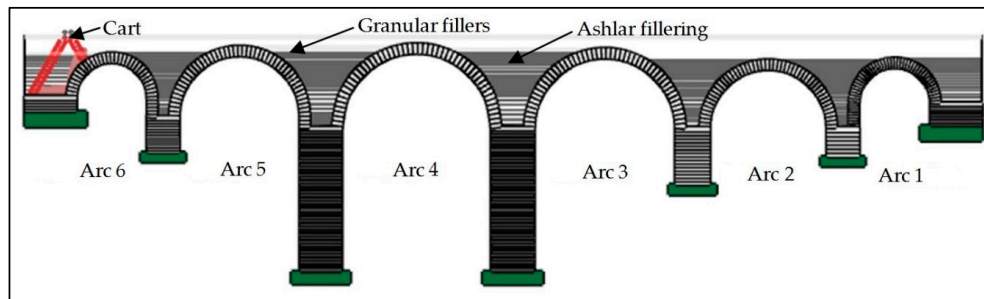
Figure 14. Model for analysis of level I.

The analysis was performed using the software Ring 2.0 [55], which has been applied in different research projects on factory bridges [56,57] (Figure 14). In this model, it was developed using the real defined geometry taking into consideration the way the fillers lay as deduced from the research using GRP and taking into account the vicissitudes that the structure has undergone.

- S0: original longitudinally sloping bridge. From the data of Bonet, 1991 [23].
- S1: demolition of arch no. 6, modelling arches 1 to 5 and longitudinal slope.
- S2: demolition of arch no. 5, modelling arches 1 to 4 and longitudinal slope.
- S3: entire bridge in the present condition.
