The influence of management and construction methods in the repair costs of Spain's low-volume road network

Eutiquio Gallego,¹ Manuel Moya,² Esperanza Ayuga-Téllez,³ Ana I. García,¹ Francisco Ayuga¹

Journal of Agricultural Engineering 2016; XLVII:537

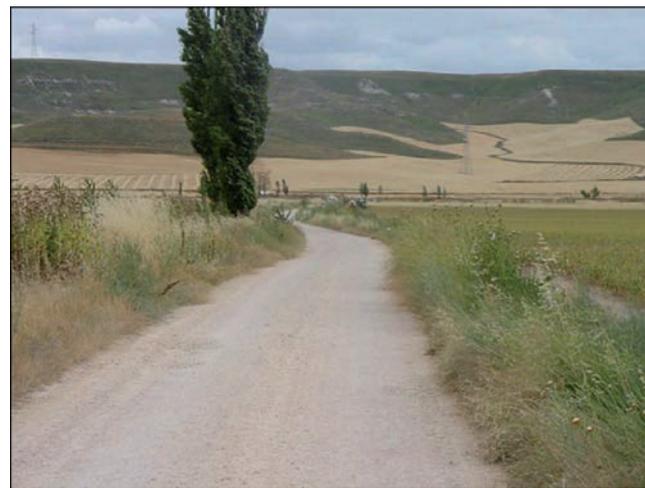
Figure 3. Low volume road paved with macadam.

The most common pavement used during this era consisted on a single base layer of macadam (Figure 3). This material consists of fractured stones 6-8 mm in diameter, which are later compacted and the spaces are filled with sand. If macadam was laid over a clayed substrate, then a granular subbase layer had to be laid below the macadam base. This kind of pavement is suitable for low traffic loads and its durability is good. Thus, the low volume roads built during this era remained in good condition for many years. At the end of this era the use of stabilised granular materials became more common, especially in irrigated areas.

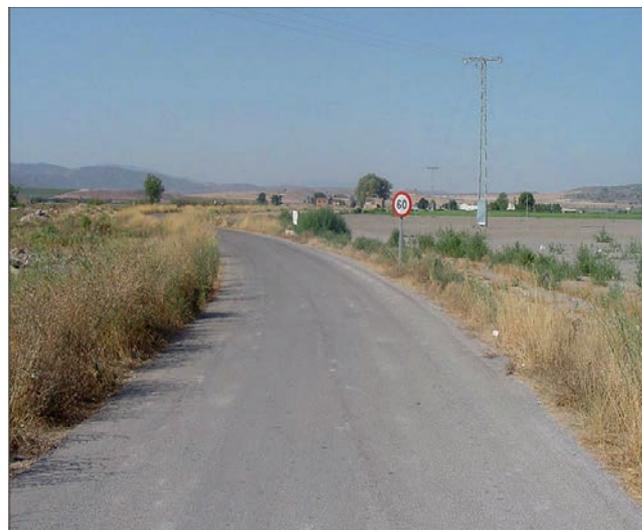
Figure 4. Low volume road paved with a double surface treatment.

The percentage with an asphalt cover grew rapidly over this era; indeed, in many areas nearly all the low volume roads laid during this period were provided an asphalt surface. This asphalt surface is generally rather than, about 3-6 cm. Sometimes this asphalt is pre-mixed, but it was quite usual to place a surface treatment. A film of binder is laid on the road and then a layer of small uniform chippings is laid immediately over it. This process may be performed only once, but it is more usual to perform it twice (Figure 4) or even three times.
